Maryland Inventory of Historic Properties number: BA-2655

Name: B-0177/Thistle Blower Stream

NAME AND SHA NO.: B-0177

Road Name and Number: Thistle Road over stream

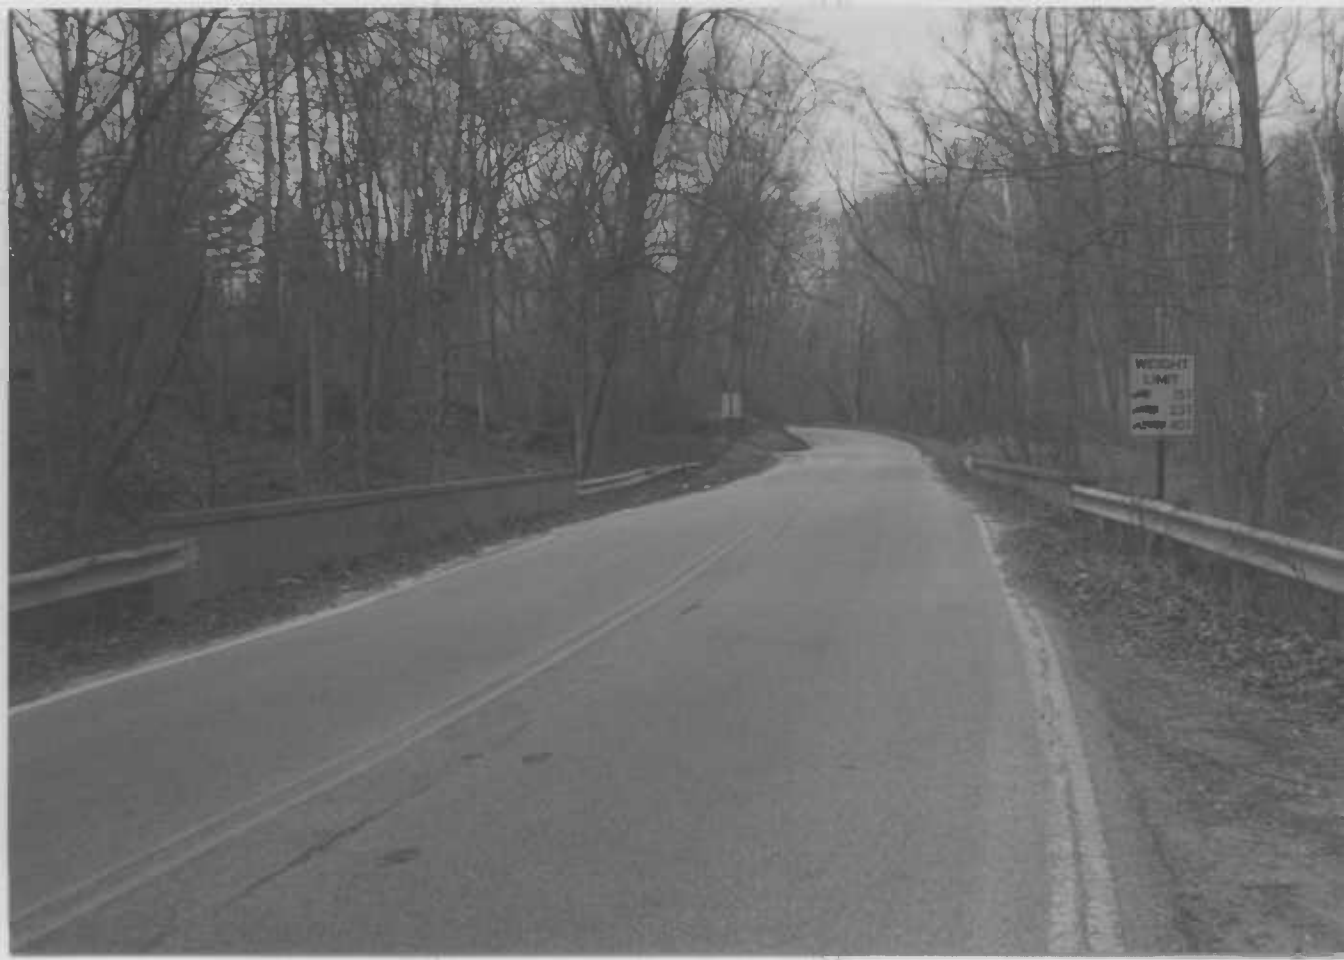
Number 17 of 374

Description SOUTH APPROACH LOOKING
NORTHWEST

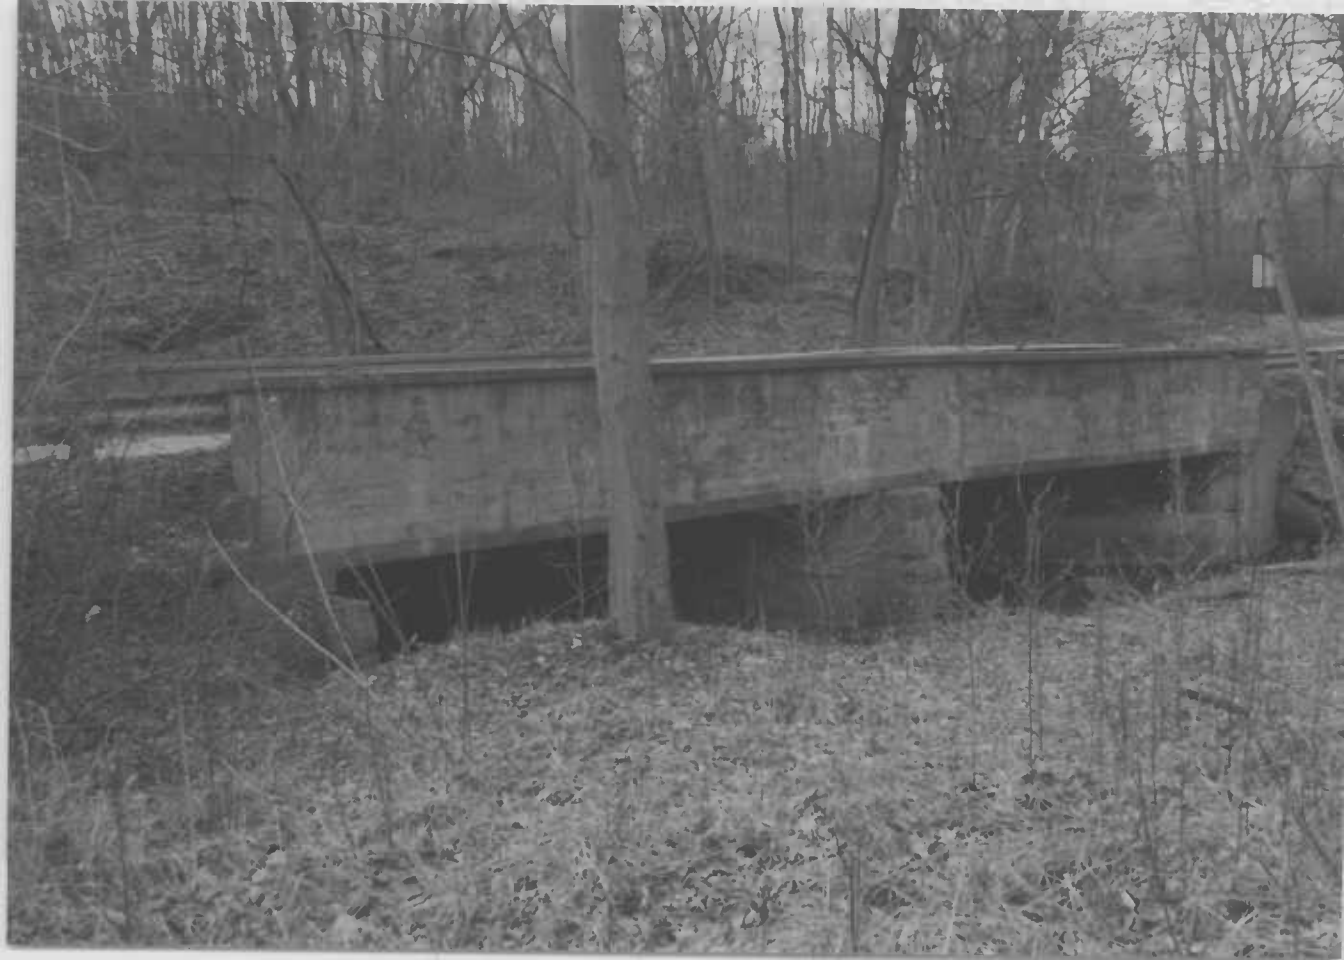
Number 28 of 39 4

Details of the bridge's present condition from a 1993 inspection report include large cracks and spalling with exposed reinforcing steel in the east parapet, and two cracks in the west parapet. The report also mentions the presence of cracking and soft mortar joints in the abutments.

Description EAST ELEVATION LOOKING WEST

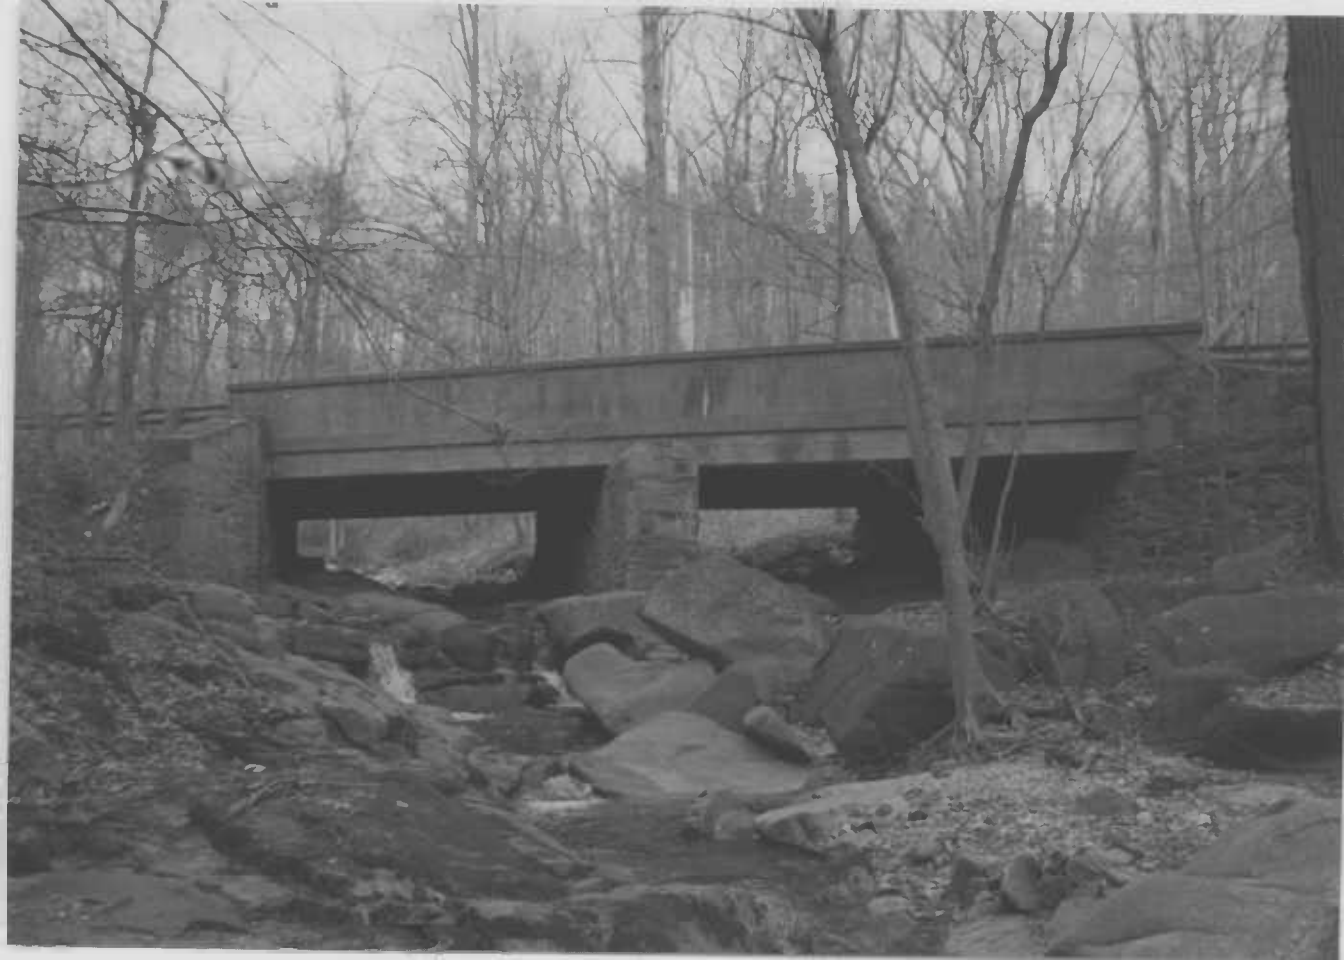
Number 3 of 374

According to Baltimore County inspection reports, this bridge was widened since its original construction. The report notes that the eastern parapet is older, indicating that the additional width was added to the western side. However, the report does not indicate when this alteration was undertaken.

Description WEST ELEVATION LOOKING EAST
